**APPENDIX E**  
**Estimation of Rock Mass Strength Properties and Evaluation of Rock Mass Structure**

**APPENDIX E.1**  
**WSDOT Memorandum Dated April 8, 2009**

SUBJECT: I-90 Snoqualmie Pass East – Hyak to Keechelus Dam  
Snowshed shaft foundations

## Snowshed Shaft Foundations: Rock Strength Estimates for DFSAP Analysis - I-90 Snoqualmie Pass East

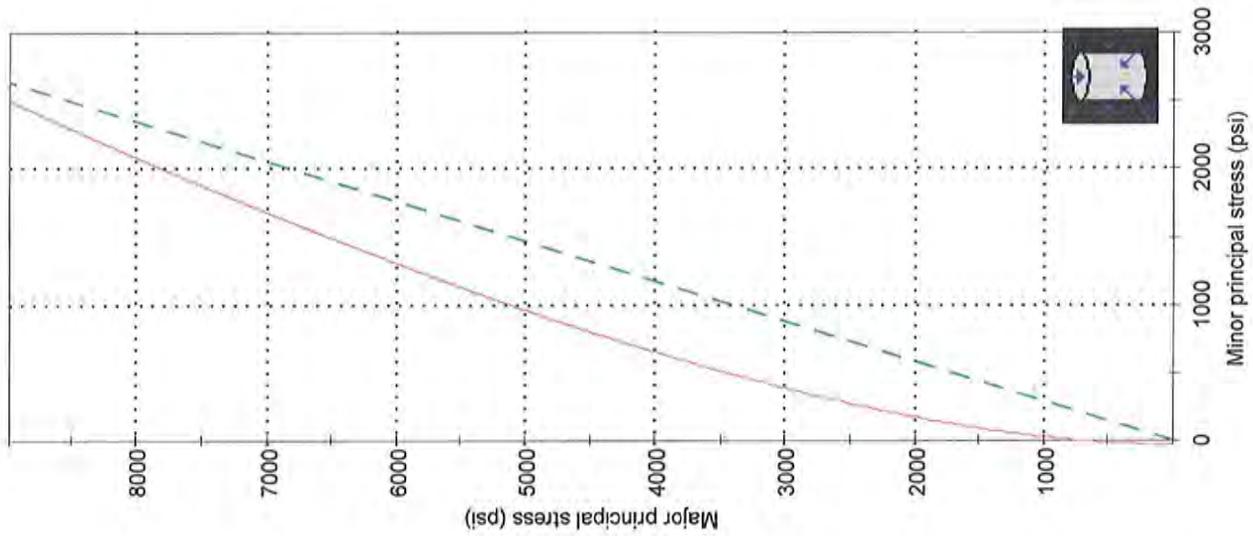
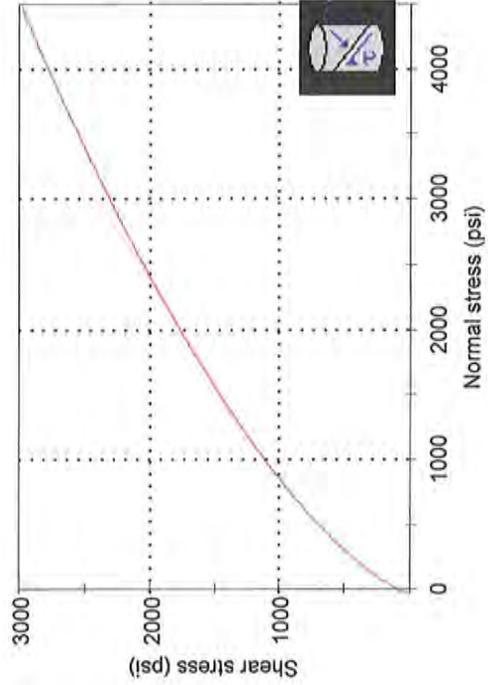
I-90 Snowshed shafts - low end strength

tensile strength = -23.056 psi  
 uniaxial compressive strength = 602.272 psi  
 global strength = 1743.335 psi  
 modulus of deformation = 921557.70 psi

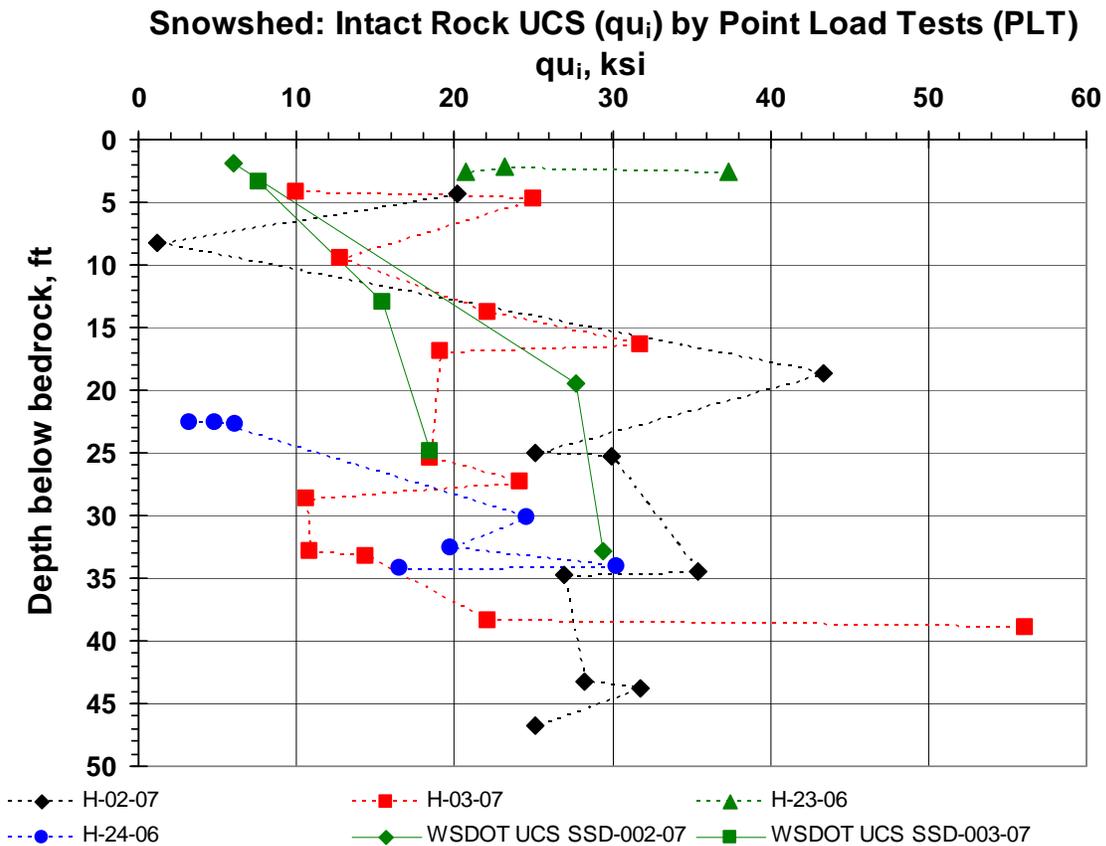
**Figure 1.**— Available Point Load Test (PLT) results for the Snowshed. WSDOT (2009) UCS test results are also graphed. Note that borings H-02-07 is SSD-002-07, and H-03-07 is SSD-003-07.

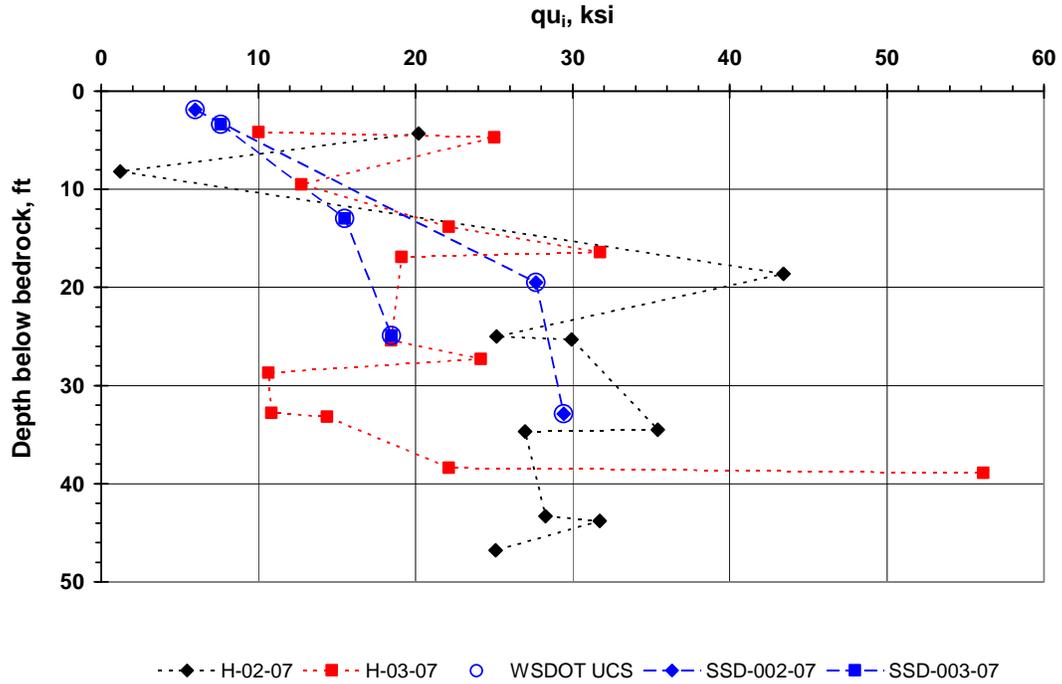
**Figure 3.**— Available PLT and WSDOT (2009) UCS test results for the two borings in Tuff. Note that borings H-02-07 is SSD-002-07, and H-03-07 is SSD-003-07.

**Snowshed: Intact Rock UCS ( $q_{ui}$ ) by Point Load Tests (PLT) & WSDOT UCS  
Borings in Tuff -- Greatest Depth to Bedrock**

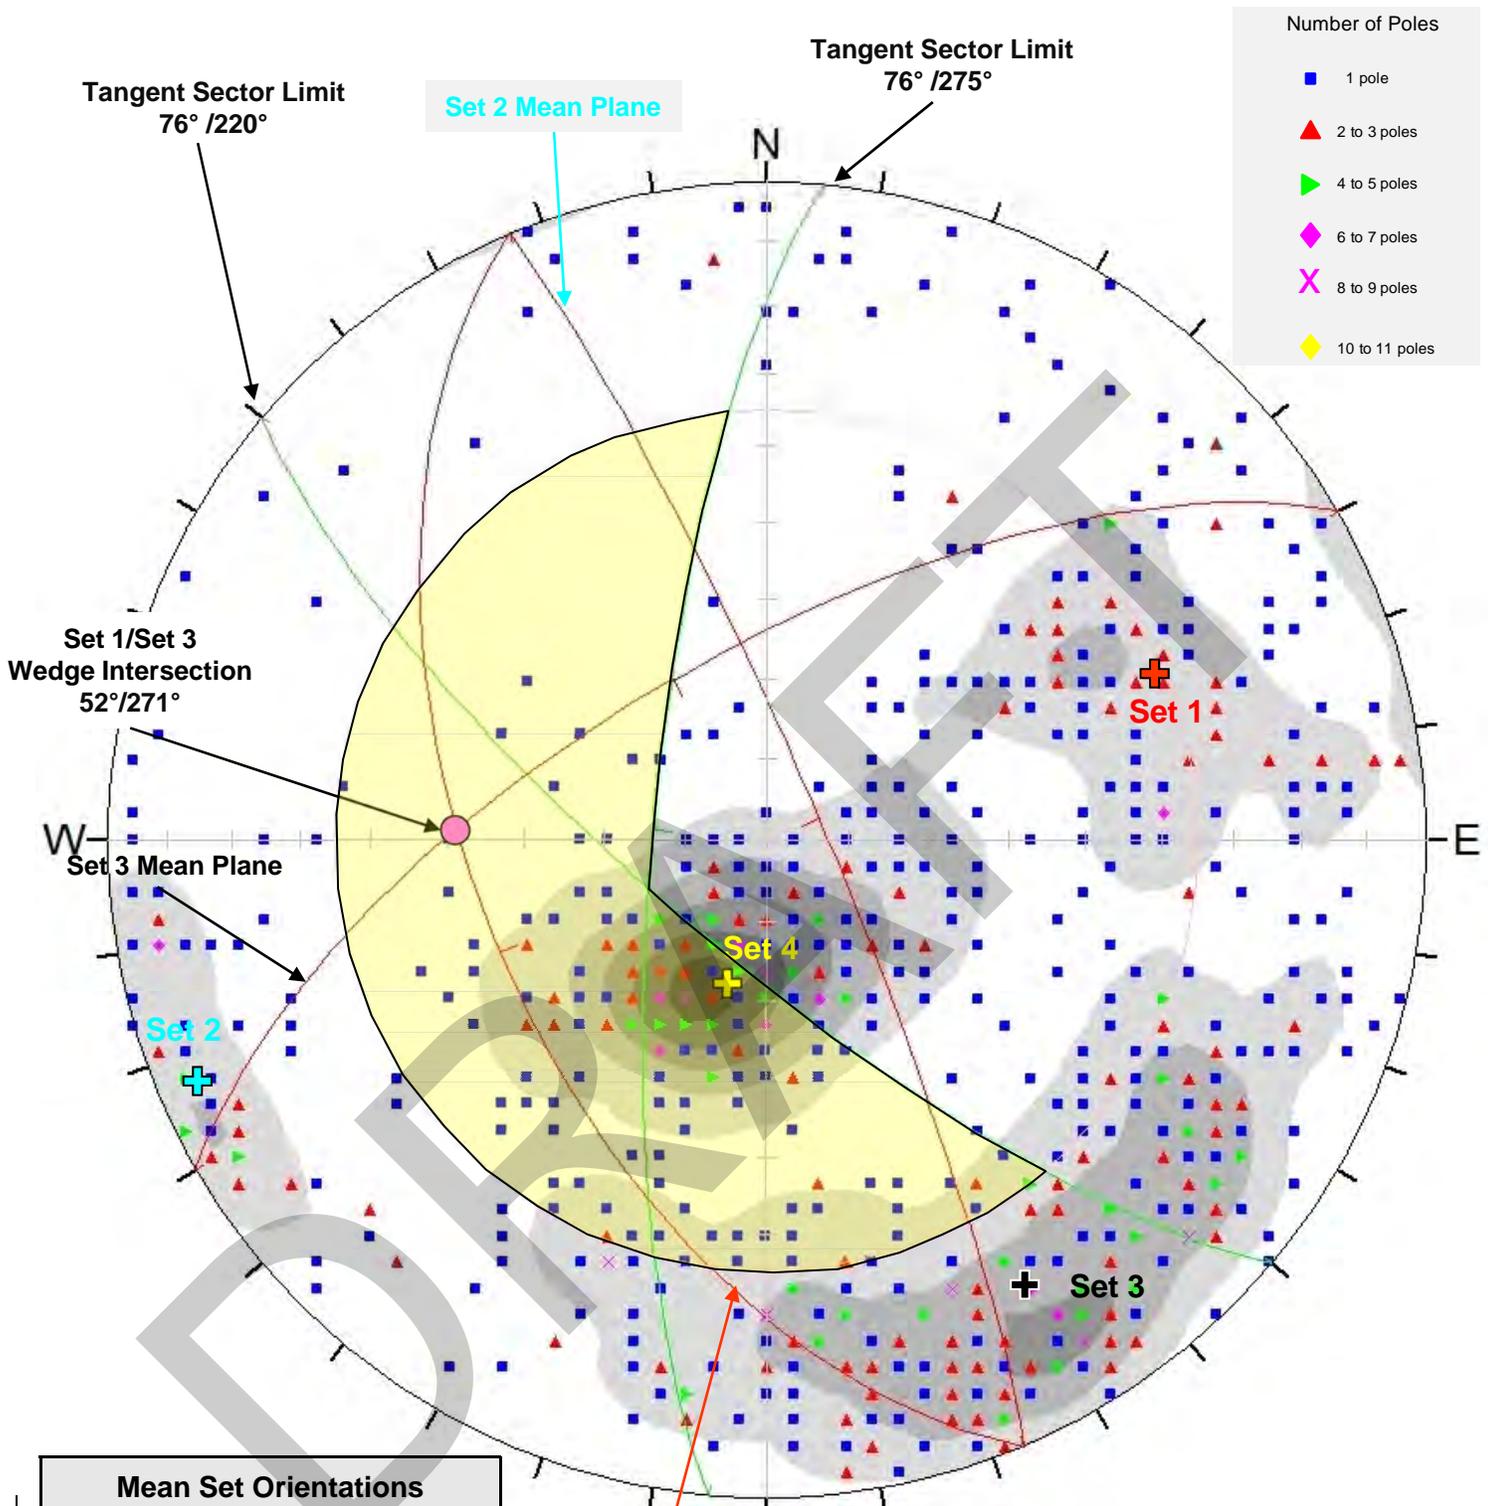
Figure 2  
Design Sector VIII (Snowshed) – Detailed Kinematic Analysis

Number of Poles

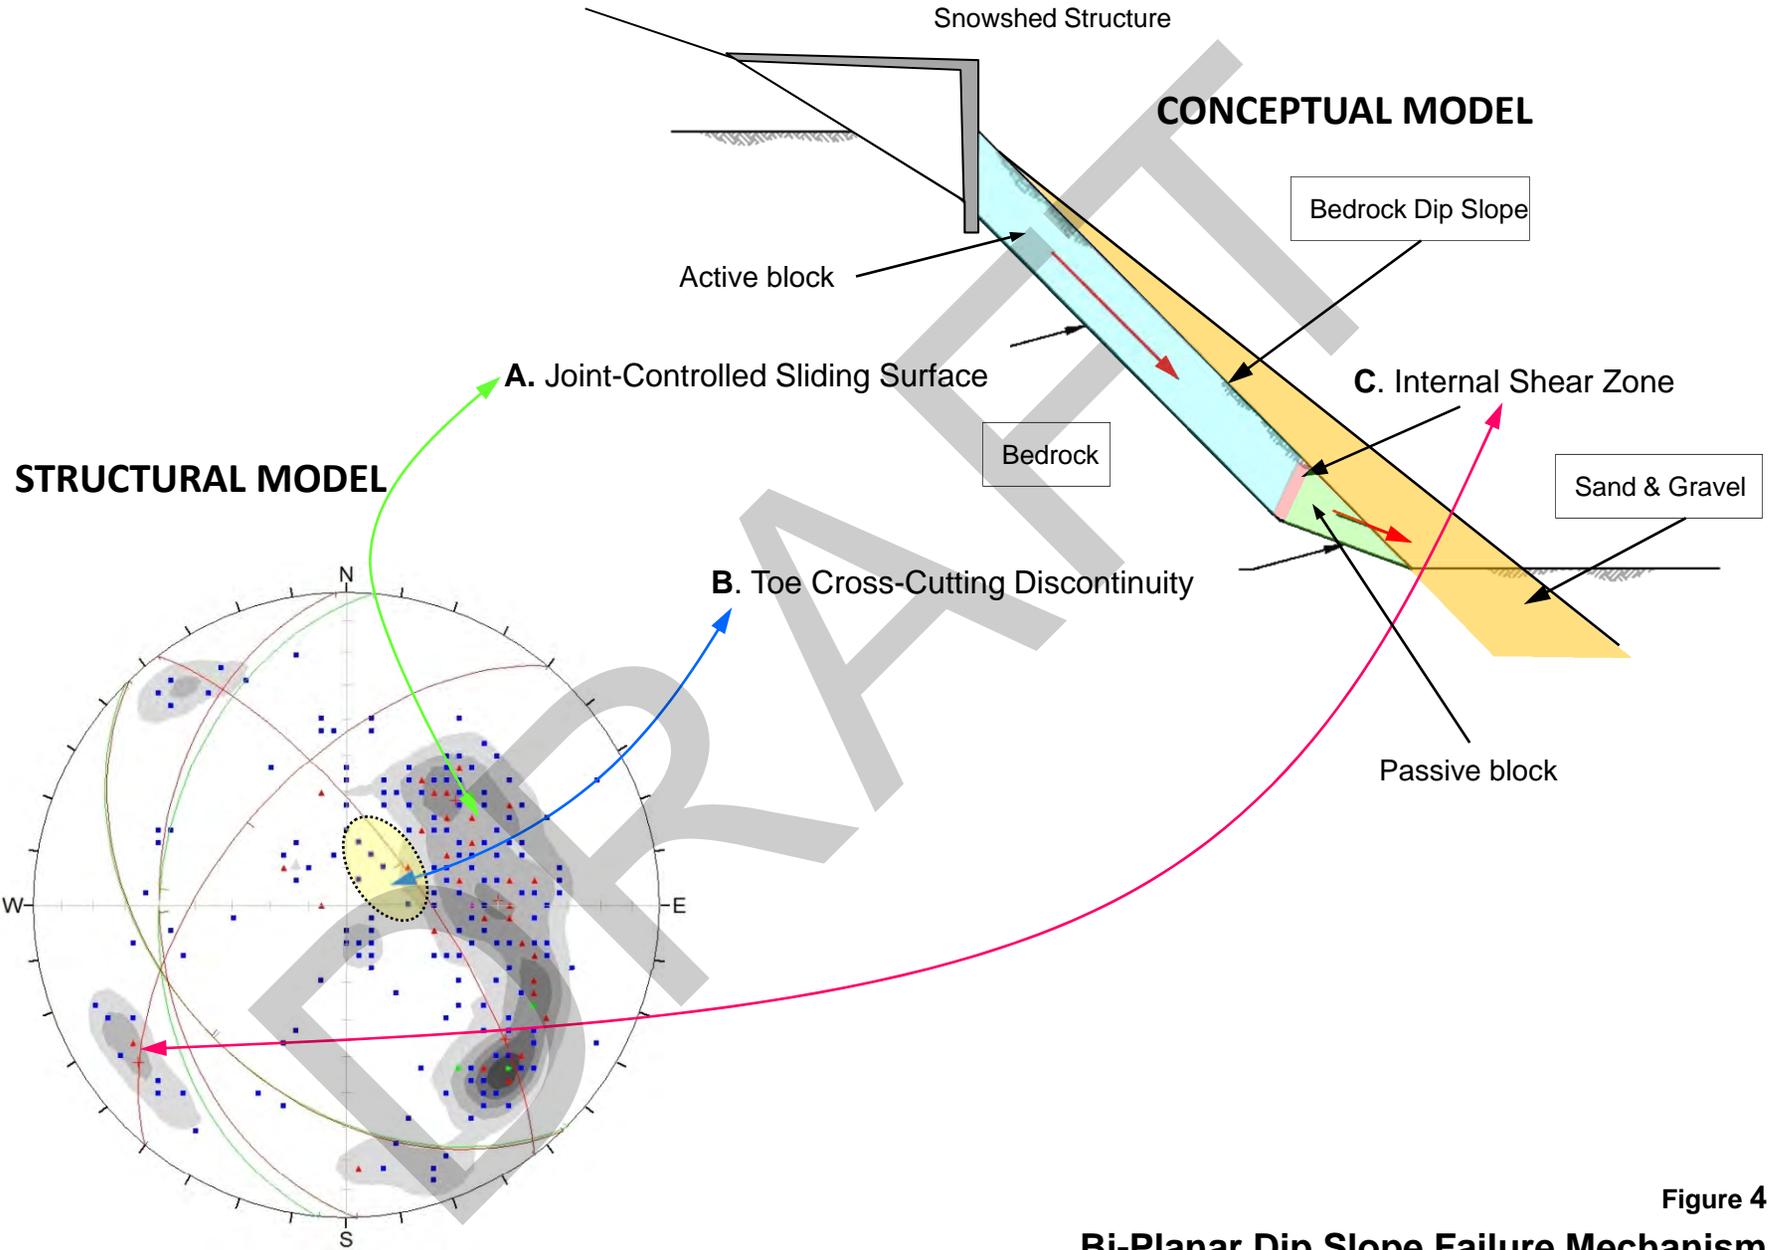
Figure 4  
Bi-Planar Dip Slope Failure Mechanism

Stereonet from COBL Data (see Figure 1)

A potential hybrid failure mechanism that is consistent with the structural geology is referred to as the "**bi-planar**" model and is illustrated in the conceptual sketch shown on Figure 4. This mechanism is also referred to as the active-passive block model. Bi-planar failures require highly specific structural orientations and are relatively uncommon. The most favorable geologic regime is that of dip slopes formed by bedding in sedimentary rock types. The essential structural features for this mechanism are three-fold and include:

- Sets 1 and 1a are inferred to be joints of limited persistence based on studies for the roadway alignment. This means that shear strength for a large scale requisite "A" surface would comprise both joint strength and rock mass strength. The resultant friction and cohesion for the surface would cause the slab resting on the 40° surface to be stable.

- The cross-over feature does not correspond to a concentration of measured discontinuities (yellow shaded area on stereonet). Therefore failure would require shearing through intact rock at the toe. The low shear stresses for slopes of this magnitude would be insufficient to overcome the shear strength of the rock mass.
