## SUMMARY OF RESULTS for Mitigating Damage Caused by Studded Tires on Concrete Pavement

## for Mitigating Damage Caused by Studded Tires on Concrete Pavements

Previously, damage caused by studded tires was difficult to quantify. With improved technology it is now possible to measure the amount of damage on concrete pavements (WSDOT is working diligently to estimate the amount of damage on hot mix asphalt pavements). It is estimated that the damage caused by studded tires on concrete pavements will require \$18.2 million for rehabilitation.

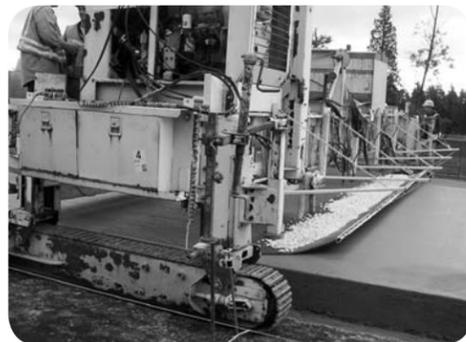
Device used for applying carpet drag.

Surface texturing technique that drags either a burlap or Astroturf™ across the wet concrete surface to create the required texture.

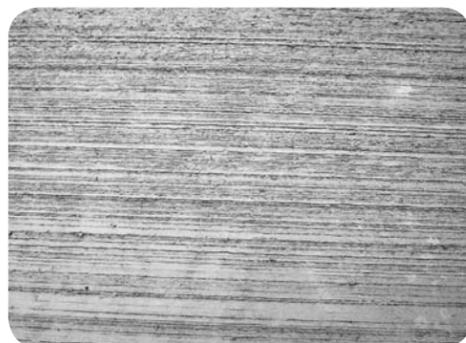
Final carpet drag finish.

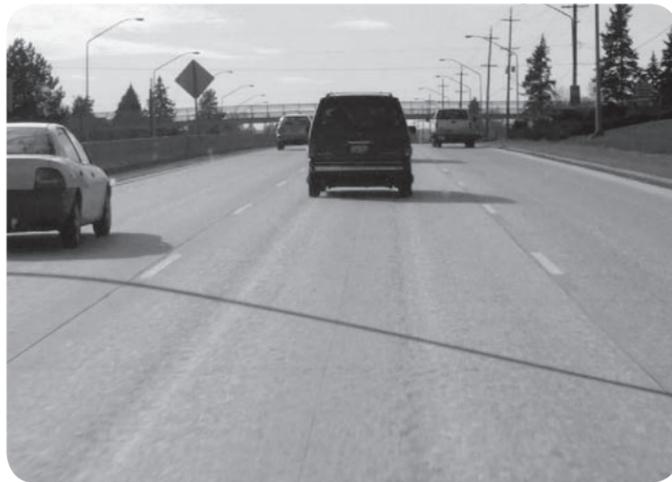
Pavement showing severe wear.

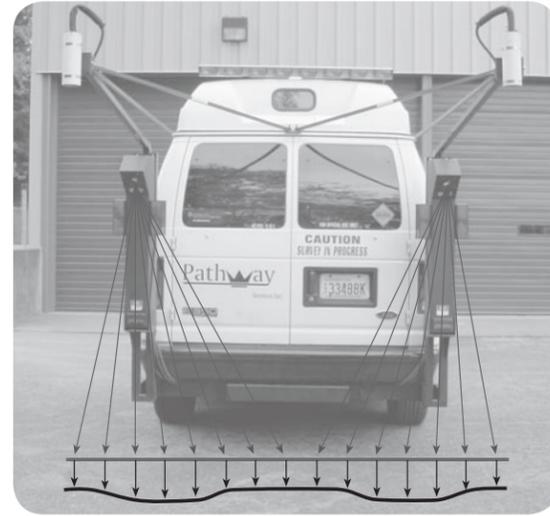
High speed van and schematic of wear depth determination.

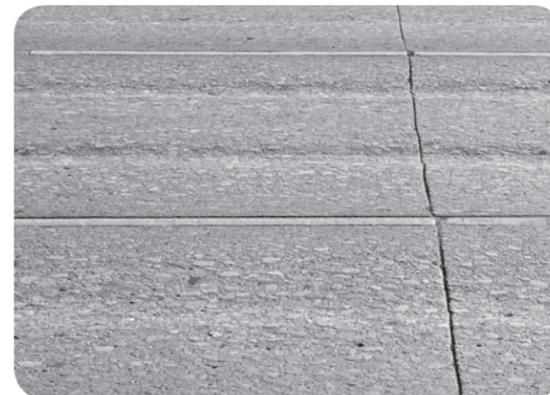
I-90 in Spokane.

The carbide steel in the studs is several times stronger than the surface of the concrete pavement. Over time the studded tires grind away at the concrete pavements surface. The amount of wear can become severe and requires pavement rehabilitation to restore a smooth, even surface.

State	Roadway	Age	Average Daily Traffic (ADT)	Average Depth of Wear (mm)
Washington	SR-395 Ritzville	11 years	6,800	1
Texas	I-45 Houston	16 years	178,000	0
Washington	I-90 Seattle – Rainier Avenue	16 years	120,000	2
Minnesota	I-84 Minneapolis	28 years	130,000	0
Washington	I-90 Preston-Fall City	28 years	50,000	7
California	SR 101 Ukiah	34 years	26,000	0
Washington	I-5 Seattle – Boeing Field	34 years	204,000	5
Washington	I-5 Tacoma	40 years	194,000	7
Washington	I-90 Spokane	48 years	100,000	7

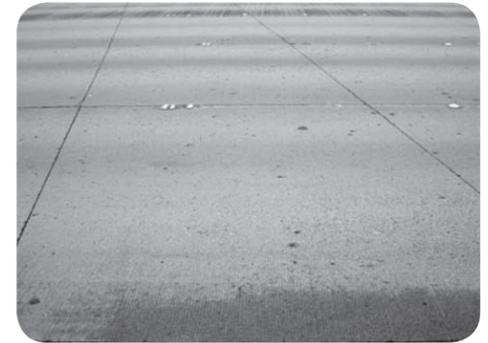
I-90 Seattle (Rainier Avenue), ADT = 120,000 vehicles, age = 16 years.

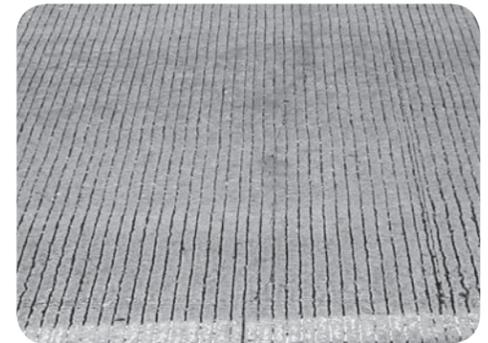
I-45 Houston, TX., ADT = 178,000 vehicles, age = 16 years.

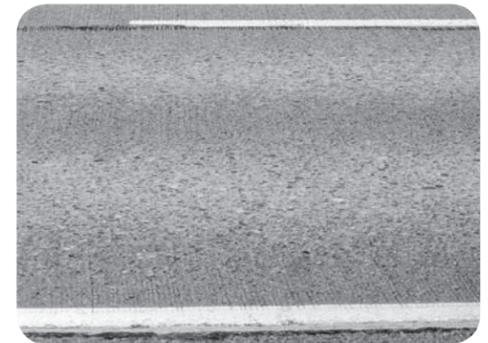
I-94 Minneapolis, MN., ADT = 130,000 vehicles, age = 28 years.
